Certified Test Report

ERMCO Components Inc.

480 Volt MOV Surge Arrester

Report No. ECI-011604LVA

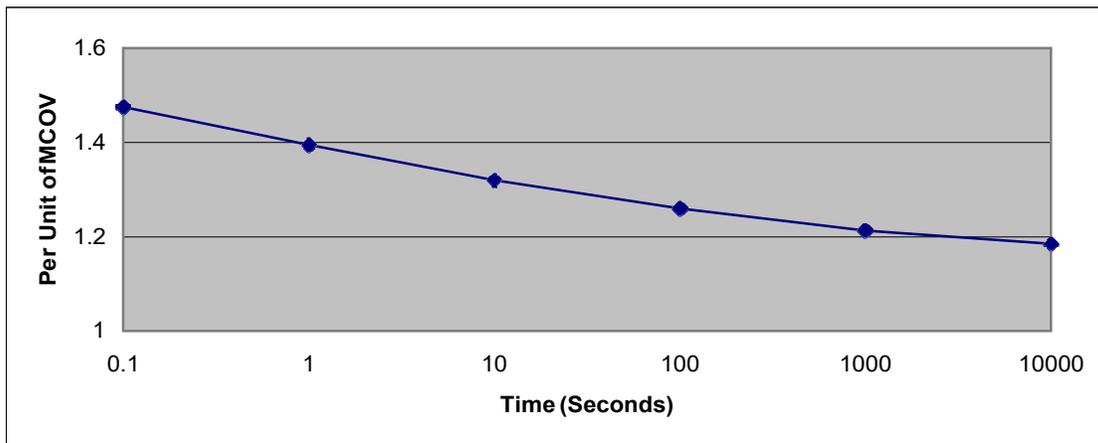
Graph 1 TOV Recovery Curve

Time, Seconds	Per Unit of MCOV
0.1	1.475
1	1.395
10	1.32
100	1.26
1000	1.213
10000	1.185

Table 2

A no prior duty test was performed on complete arresters. The results are shown in graph 1 and table 2 in Appendix 1. TOV capability as defined by IEEE C62.11-1999 was demonstrated.
